DIGITAL DENTISTRY

“CARIVU DECAY DETECTION BY DEXIS”

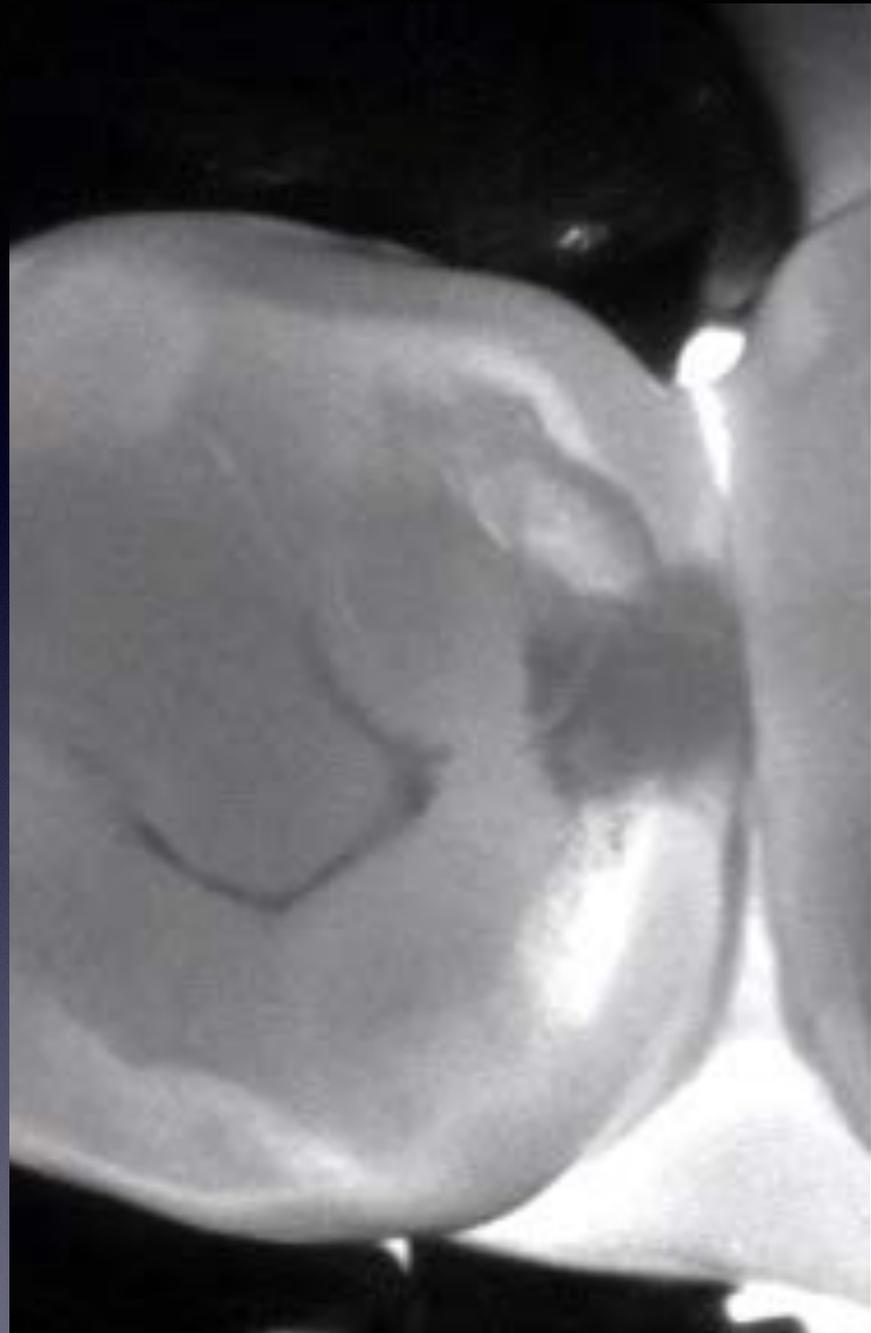
The Final Image

Thus, lesions and cracks will appear as dark (radiolucent) areas.
(Restorations will show as dark areas as they block the path of light)

Looks like an “x-ray” but without the RADIATION

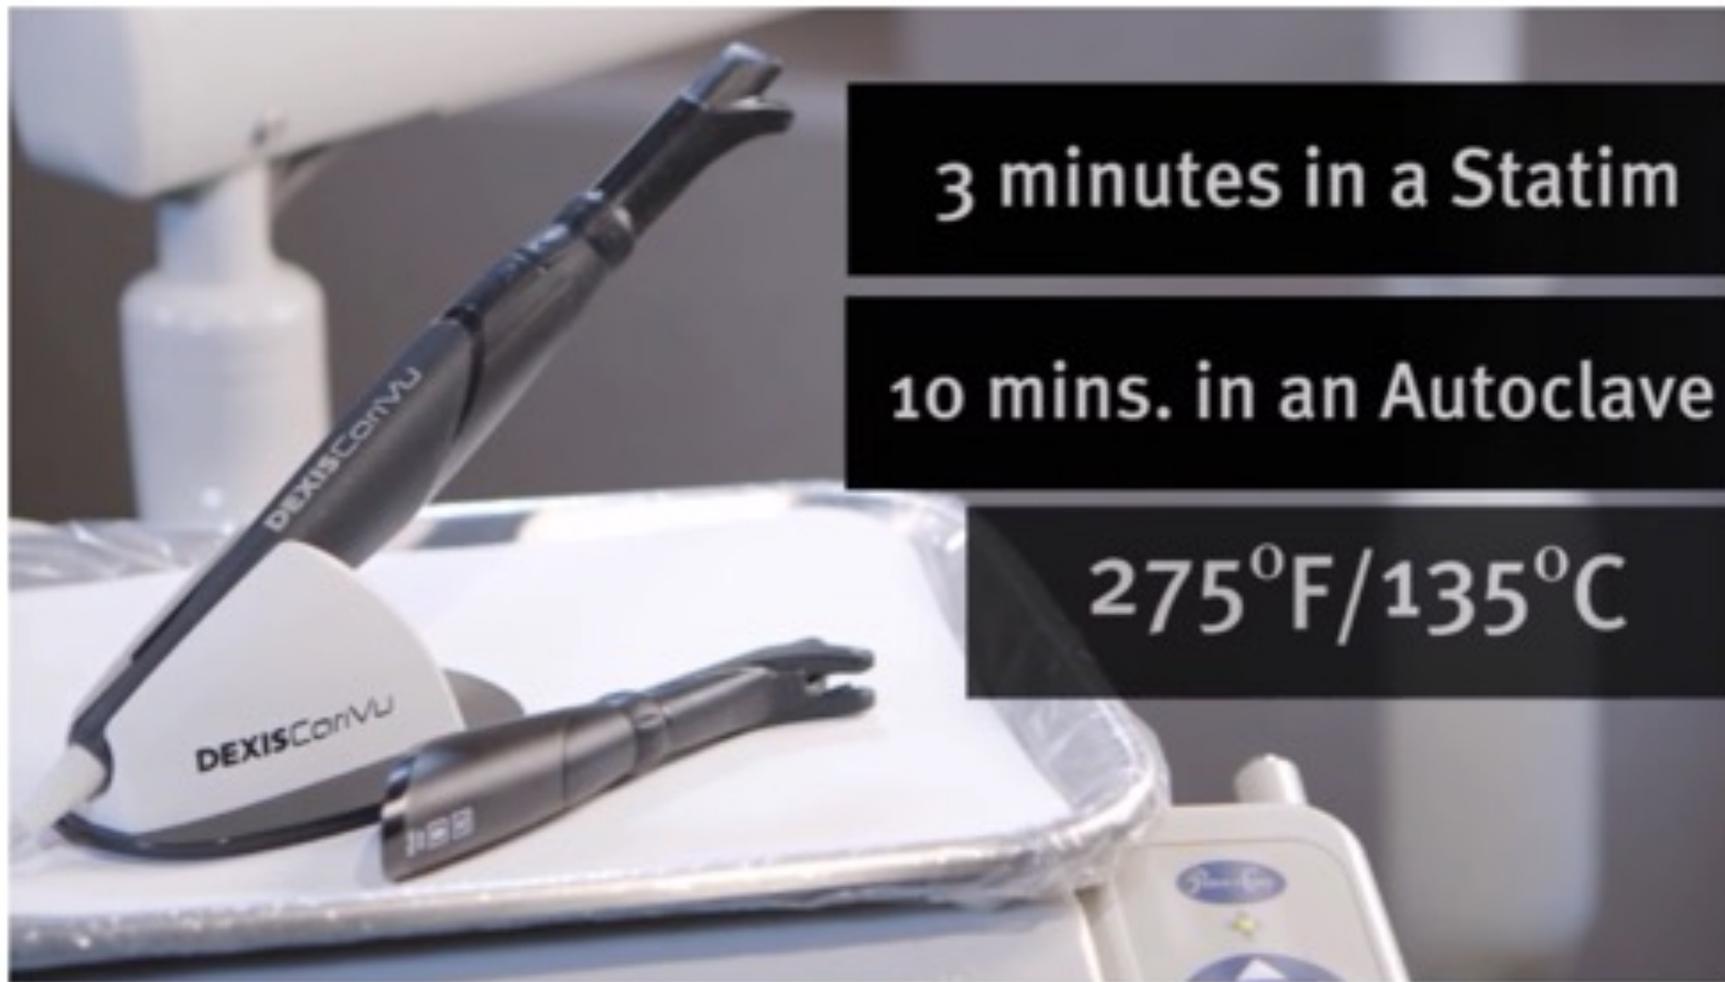
Tip Components

3 minutes in a Statim

10 mins. in an Autoclave

275⁰F/135⁰C

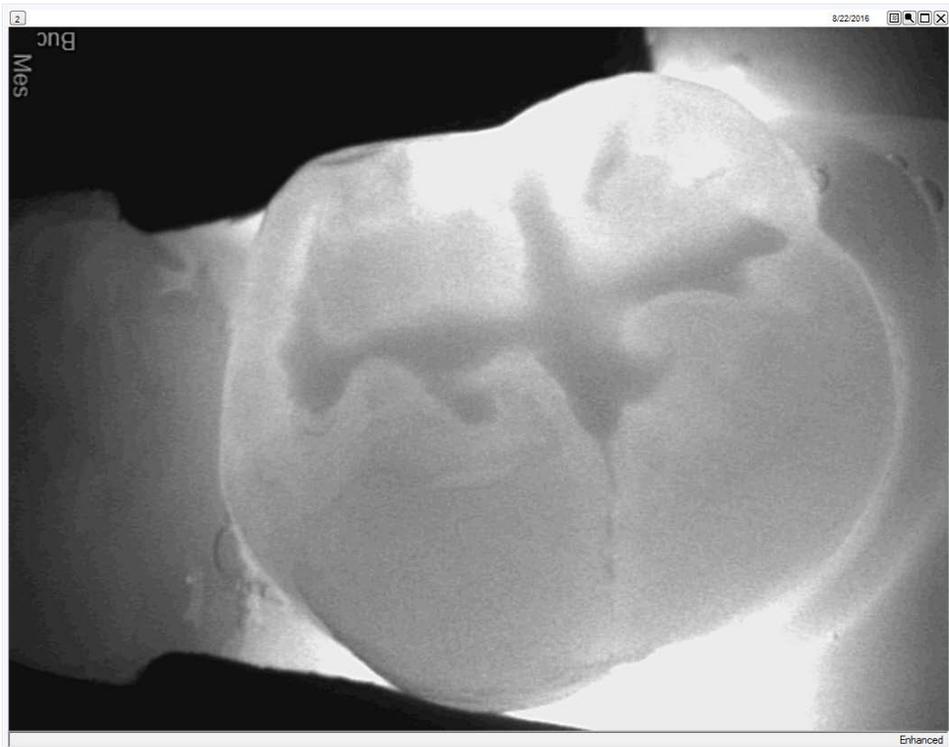
Patient profile: 16 years of age. No history of decay. OHI(floss daily, fl TP, and 6mo recall with sealants).

Presents with: CariVu:19 reveals healthy tooth structure with an intact sealant material placed 5 years ago. No apparent suspicious areas

Recommended treatment:
Due to excellent oral hygiene this patient is reinforced to continue the same at home protocol and 6 mth appts.

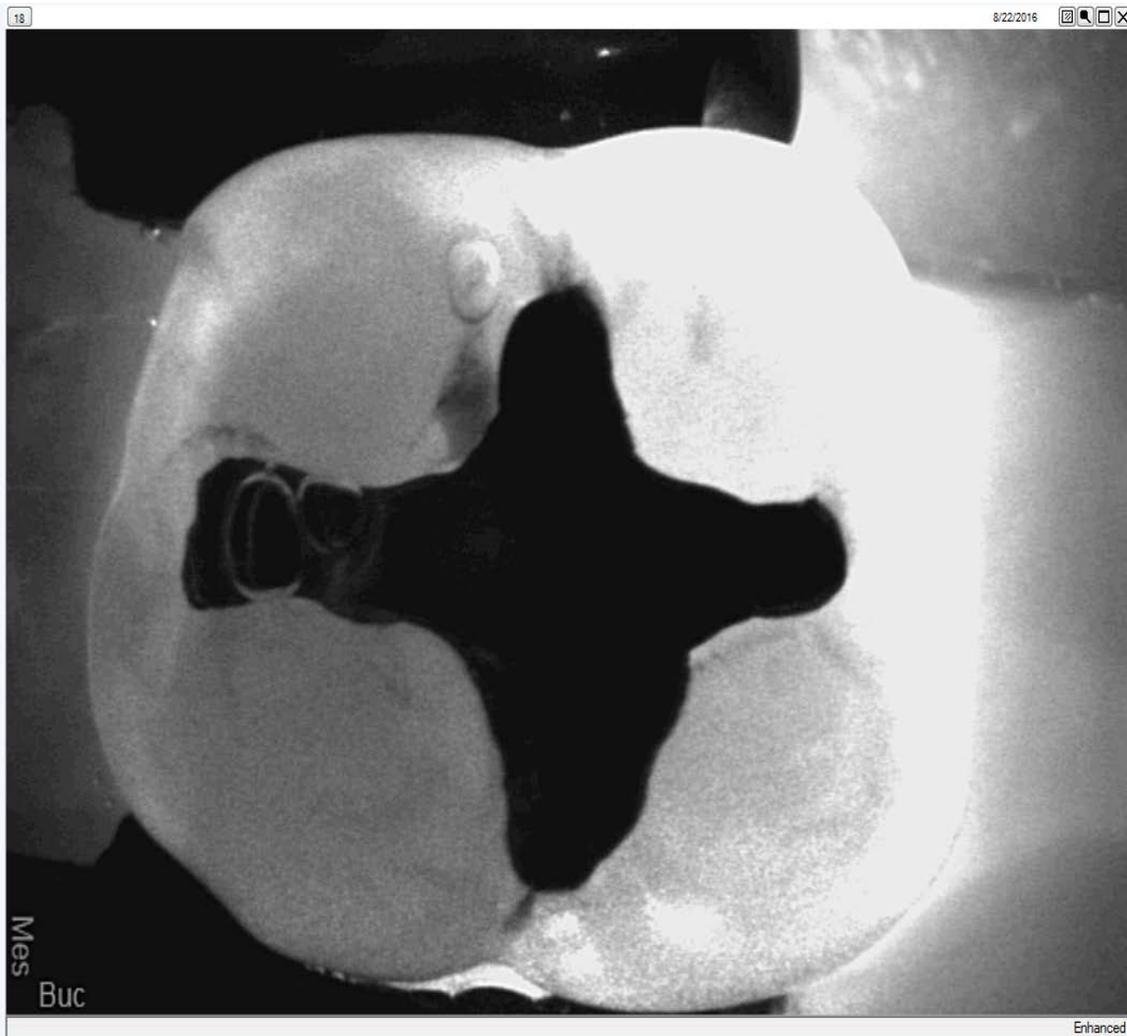
Patient profile: 46 years of age female. Old fillings, history of grinding and clenching. Drinks occasional sodas. On meds that cause dry mouth.

Presents with: CariVu: 19 old amalgam filling. Other new restorative re-done with composite. Observe small radiolucent area from open margin.

Recommended treatment: Possibly remove old amalgam and place composite, recommend night guard, fl application every recall visit. Home fluoride trays may be recommended for preventive care.

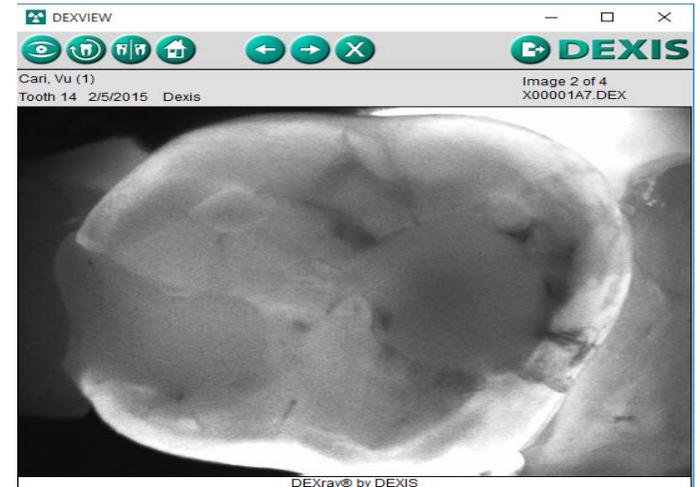
Presents with: pain upper left quadrant area of # 14-15.

Radiographs: Inconclusive

CariVu: 14 reveals two large composite restorations with suspicious radiolucent areas. Also, multiple fractures are noted. #14 fracture deep as revealed by the discoloration on the distal.

Presents with: pain upper left quadrant area of # 14.

CariVu: #14 reveals a large fracture line on the distal. Fracture appears deep as is indicated in the dark radiolucent internal appearance. Also, the radiolucency is visible on both sides of the fracture.

Due to the large fillings, evidence of multiple fractures, and symptoms - a crown on # 14 and #15. Also, with a history of decay, dental disease OHI should include Fluoride and recall every 3mths.

Due to the large fracture, and symptoms a crown on # 14 is recommended. Also, with a history of decay, dental disease. OHI should include Fluoride and recall every 3mths. Plus, this patient should be monitored for clenching or grinding due to evidence of additional fractures on #15 that is not yet radiolucent. Bite guard may be required.
